**RE: Clean Harbors Wichita, LLC Part B
Tank Certification Statements**

Clean Harbors Wichita, KS facility Tank V-1 Hazardous Waste Storage

Conduct and internal and external visual and ultrasonic thickness evaluation of the inspection of Tank V-1 in accordance with the API 653 Code regulations and guidelines.

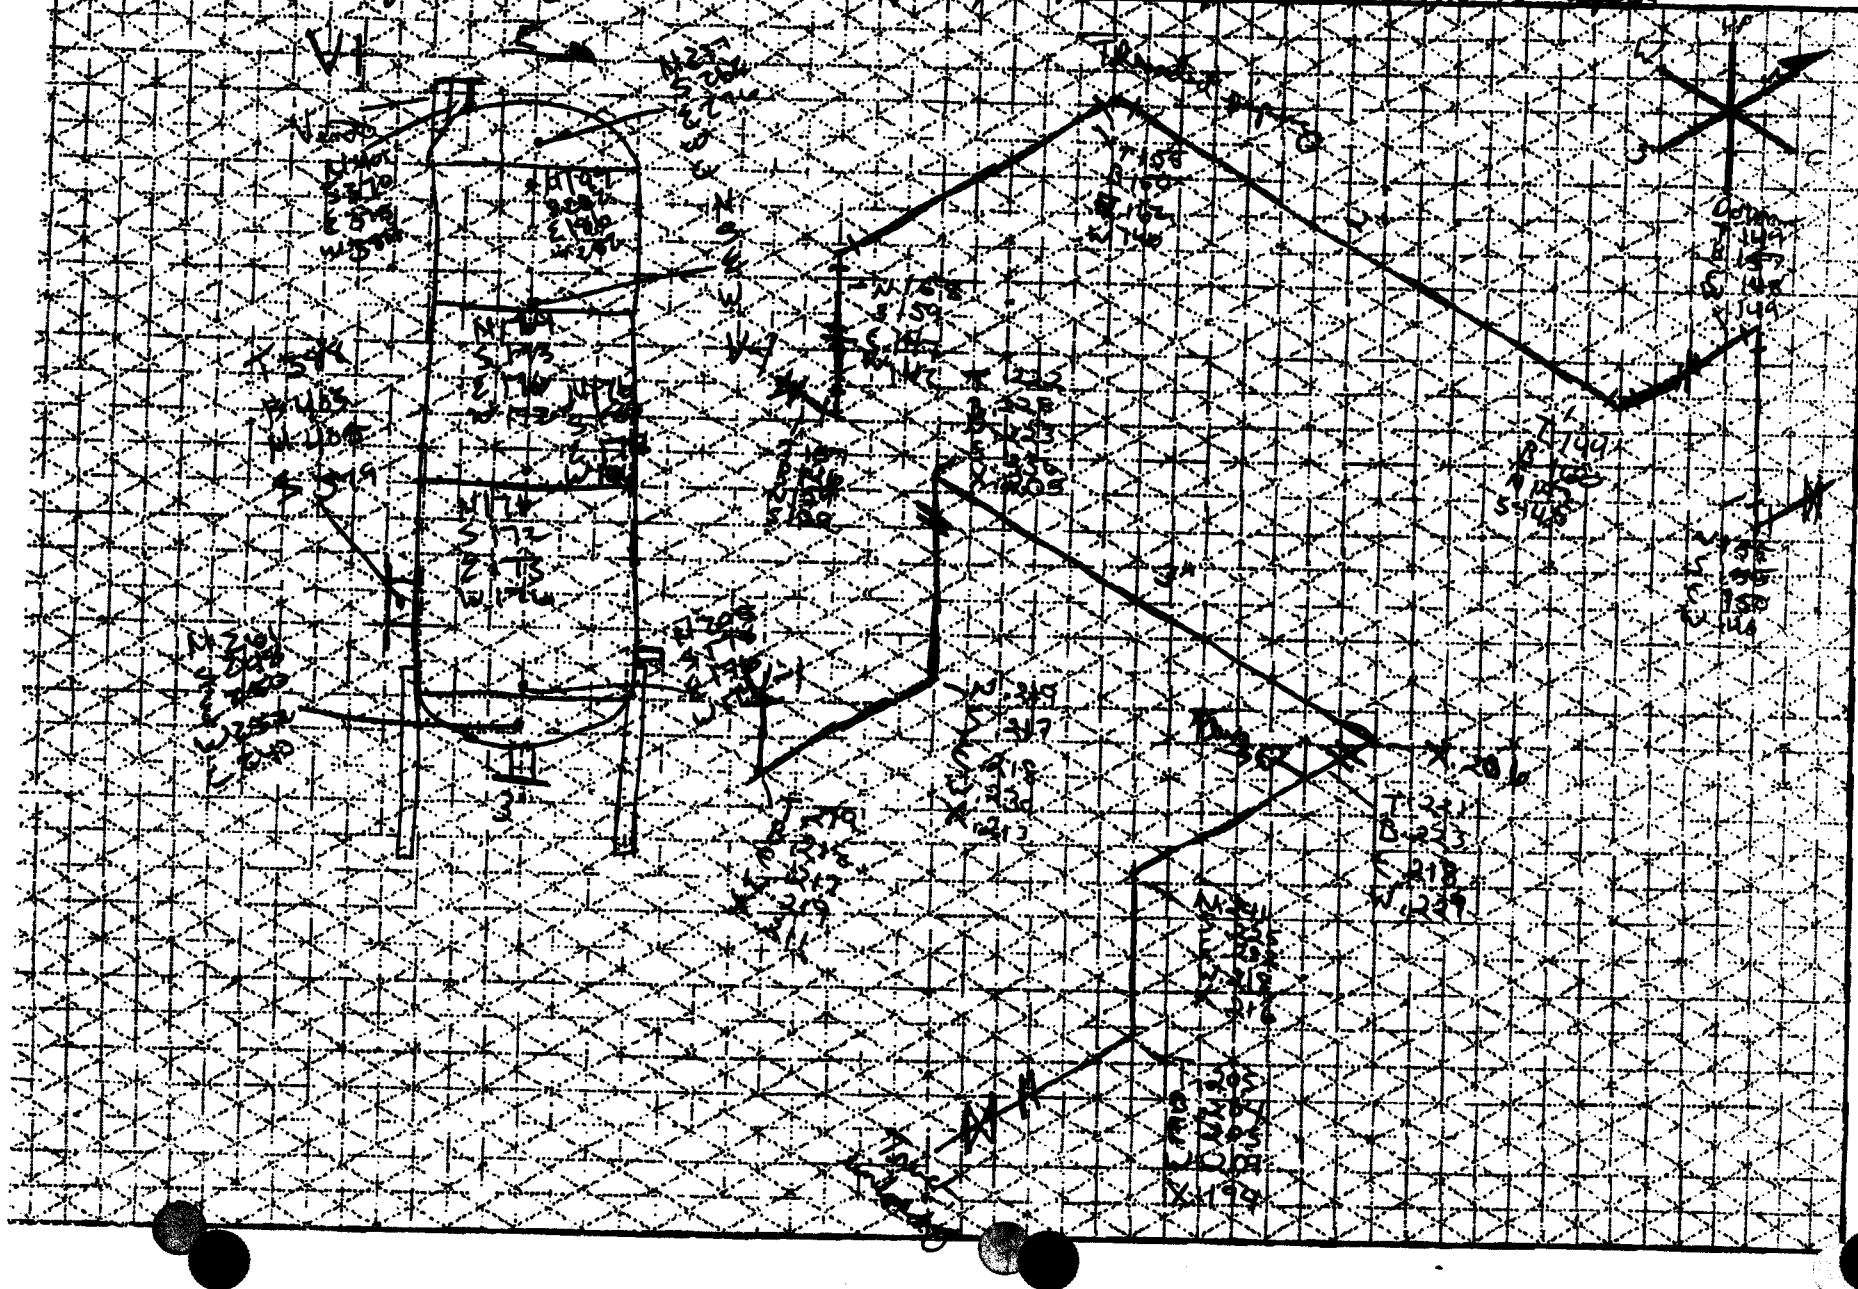
The shell showed corrosion with depths of .010" to .125" in the bottom foot of the tank.. Thickness readings were consistent with the 3/16" nominal thickness noted on the drawing leaving an approximate thickness of .06" remaining. Giving reason for the plate welded on the external surface for added thickness and support. The welds that were accessible showed no signs of cracks or defects detrimental to use.

Localized pitting on bottom head and field part of shell from bottom - $\frac{1}{16}$ " - $\frac{1}{8}$ " depth

Have engineering study of external patch be performed to determine acceptability of repair to pitted areas. The coating on the vessel be repaired and repainted as required.

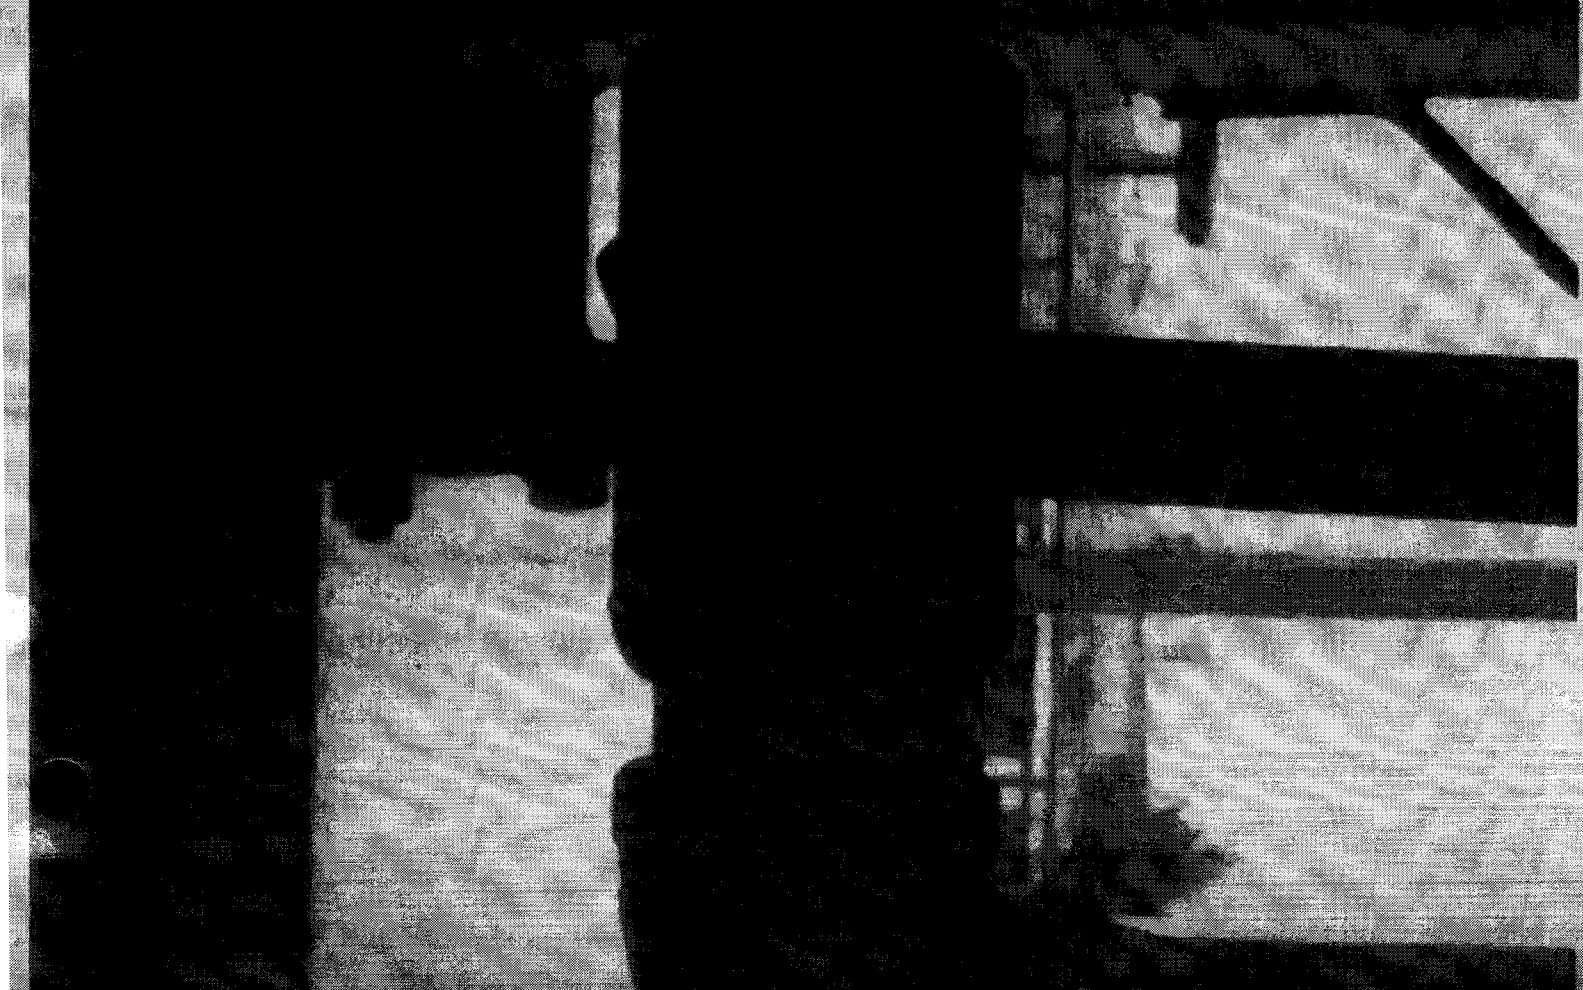
Under the 2" nozzle is an area approximately 3" in diameter that has corrosion nearly through wall. The rest of the tank has general pitting was noted throughout with minimal depths. Thickness readings were consistent with 1/4" SA36 Carbon Steel noted on drawing.

2 1/2" hole in floor heavily
corroded area.

grounding clamp
held on by "C"
clamp

Recommend welding patch over corroded area on east side of tank under the nozzle.

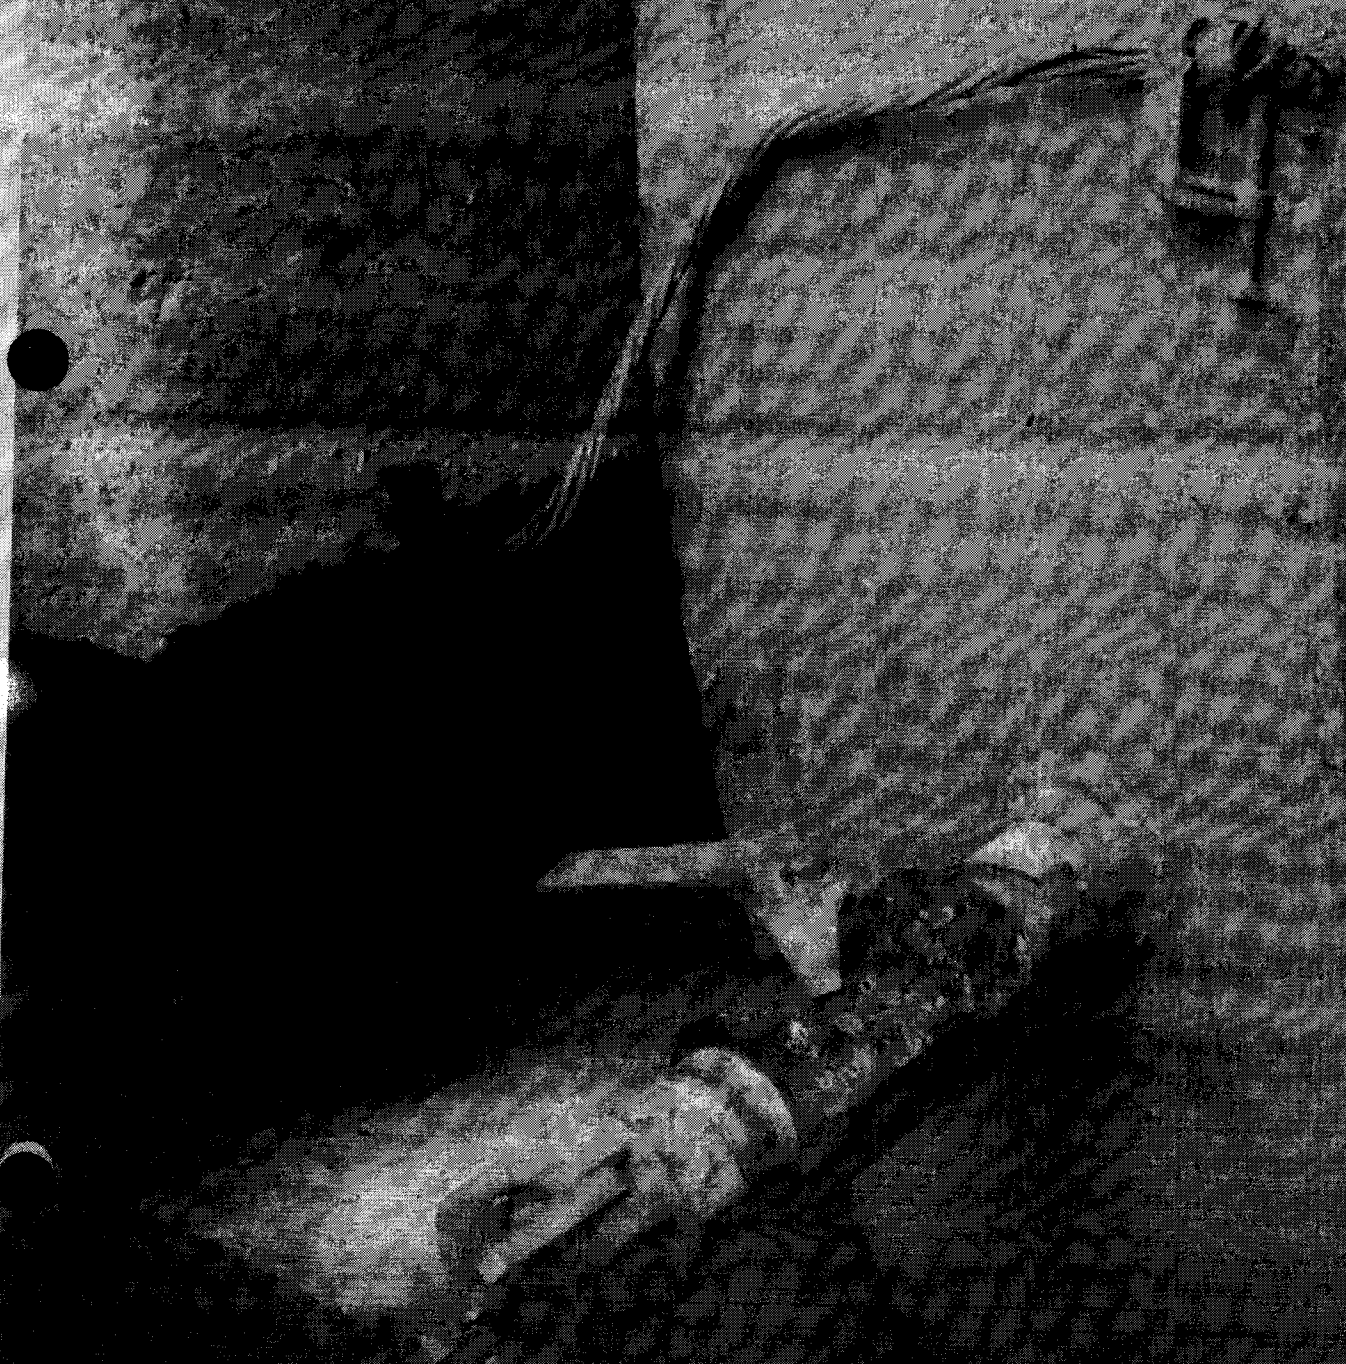
The head has several coating failures. Thickness readings were consistent with 1/4" SA36 Carbon Steel noted on drawing. See drawings for thickness readings. The inspection hatch has corrosion on the gasket surface of the hatch.

corrosion on
hatch seal

paint failure on
roof

scale
on
hatch
ring

hole in floor

Replace gasket on to inspection hatch.

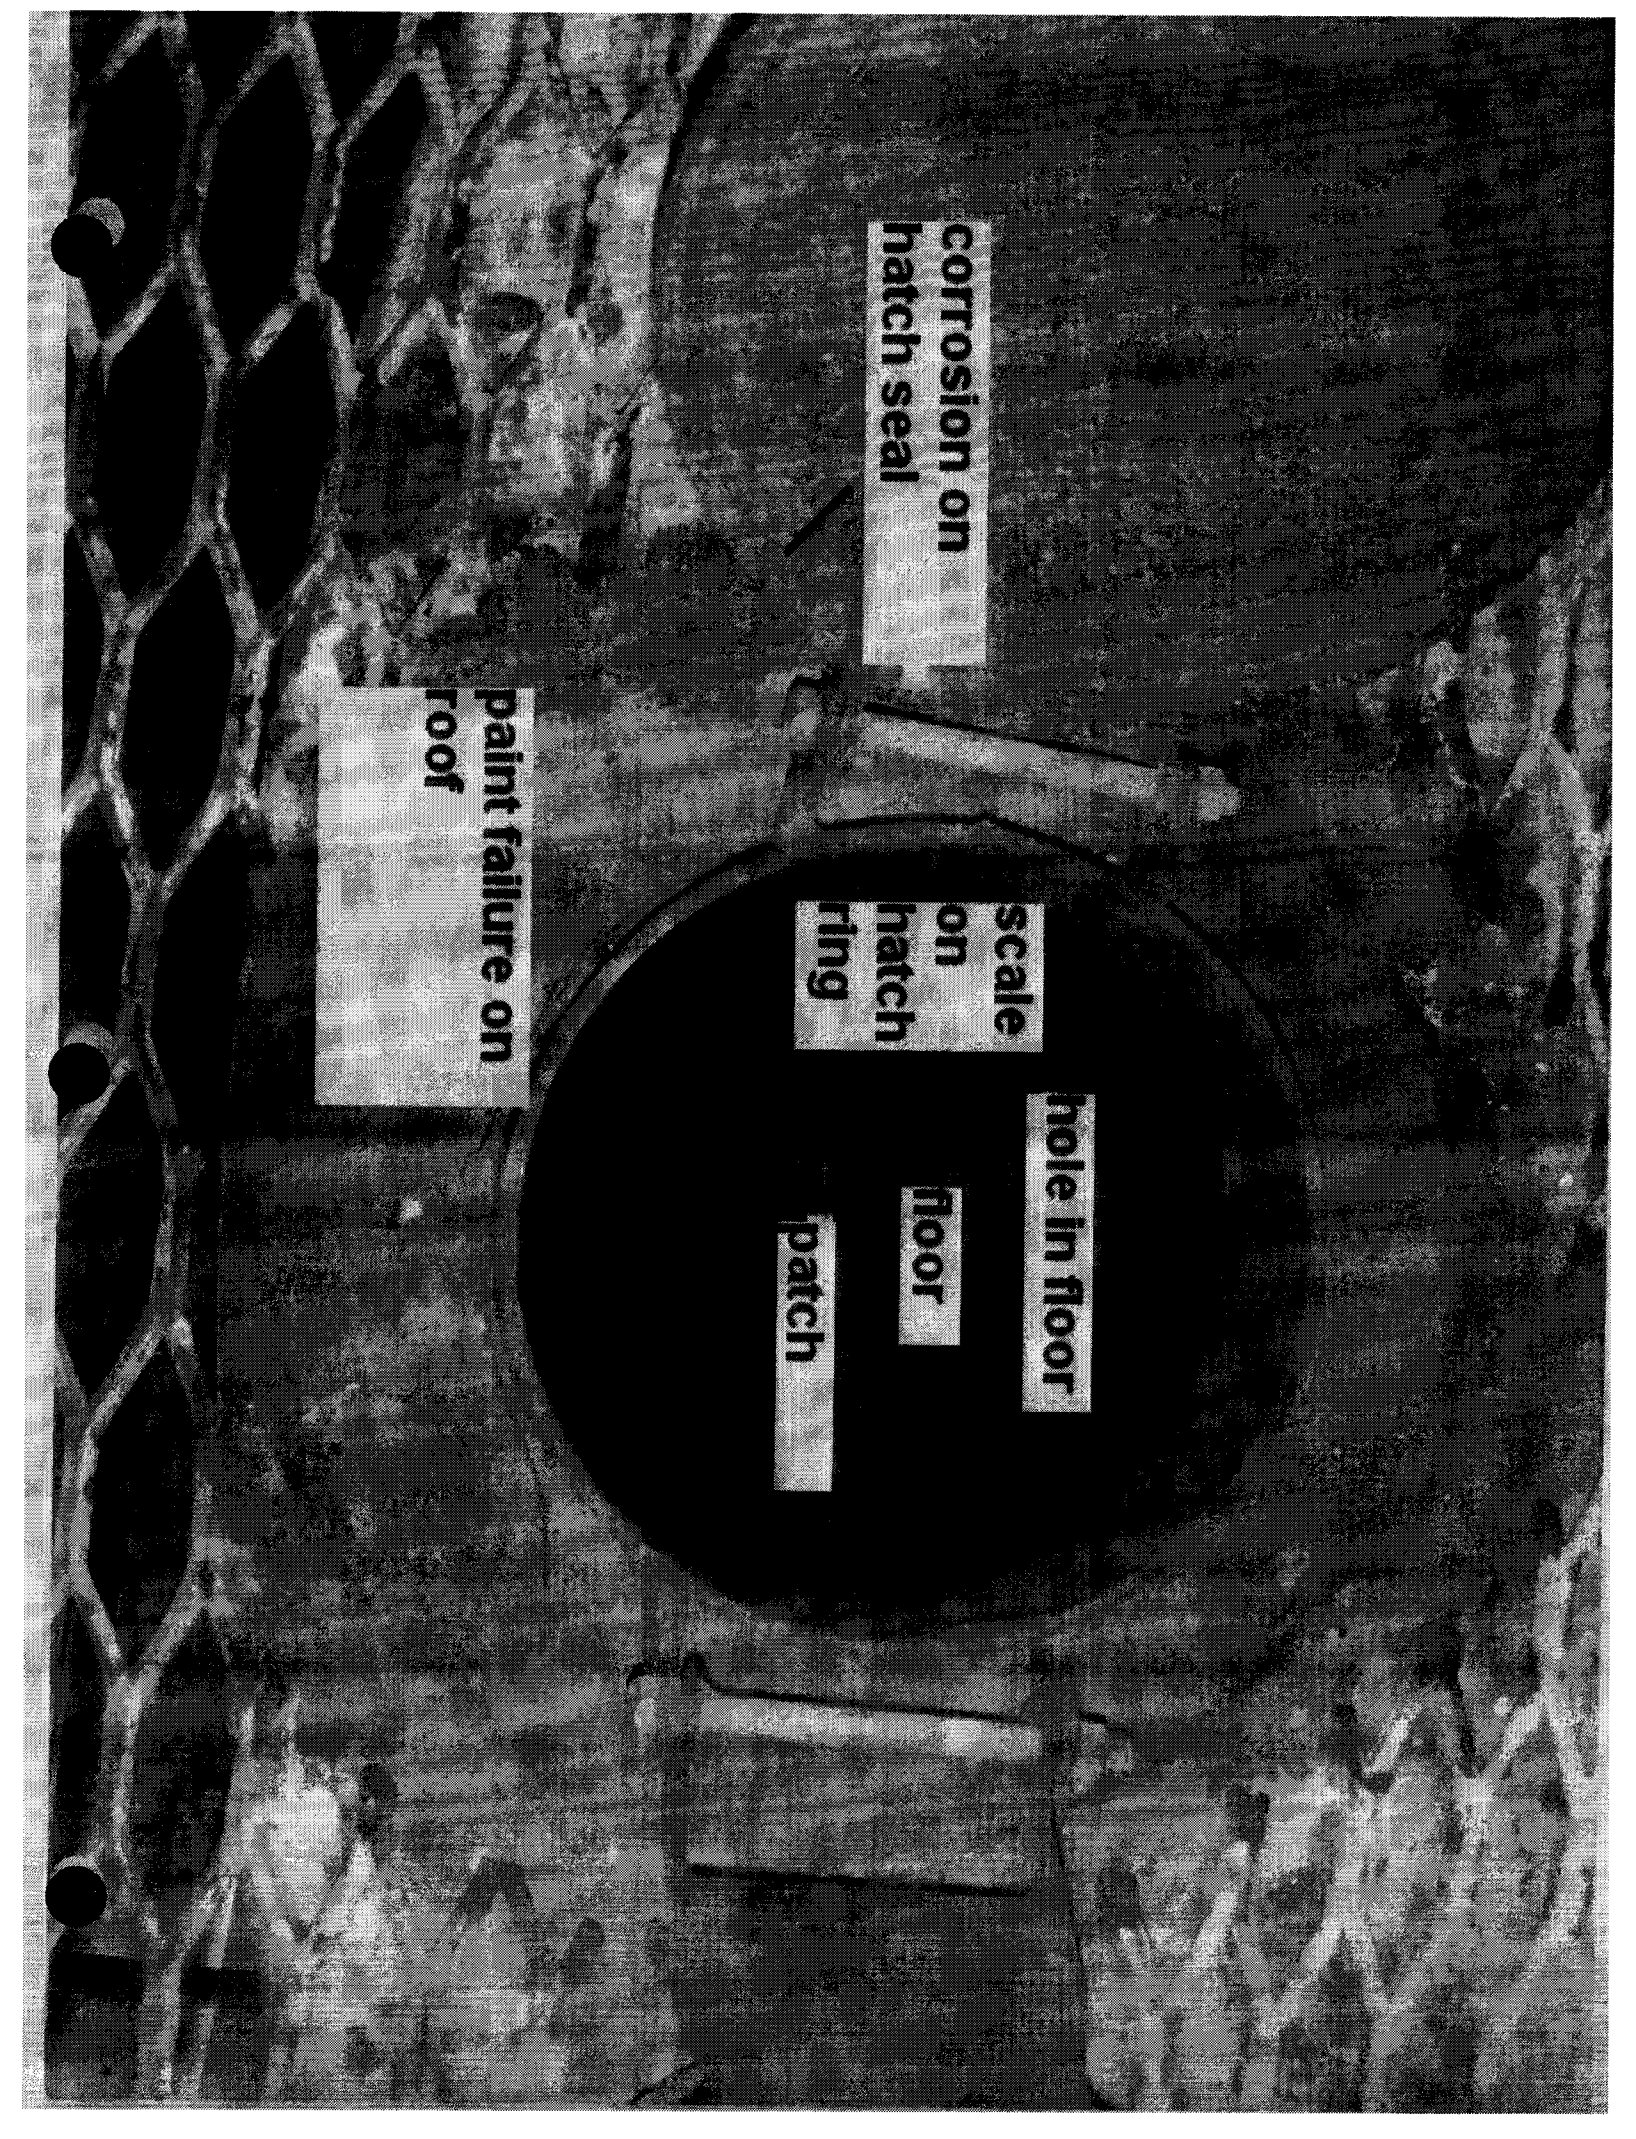
The shell showed corrosion with depths of .010" to .030" in the bottom two feet of the tank. Thickness readings were consistent with the 3/16" nominal thickness noted on the drawing leaving an approximate thickness. The circumferential welds that were accessible showed no signs of cracks or defects detrimental to use. The 3" nozzle weld on east side of tank is corroded and lacks build up. The nozzles were clean and showed no signs of internal corrosion.

GENERAL CORROSION
throughout, 0.12" max.

Corrosion in weld zone

corrosion
in heat
affected
zone,
0.10" deep

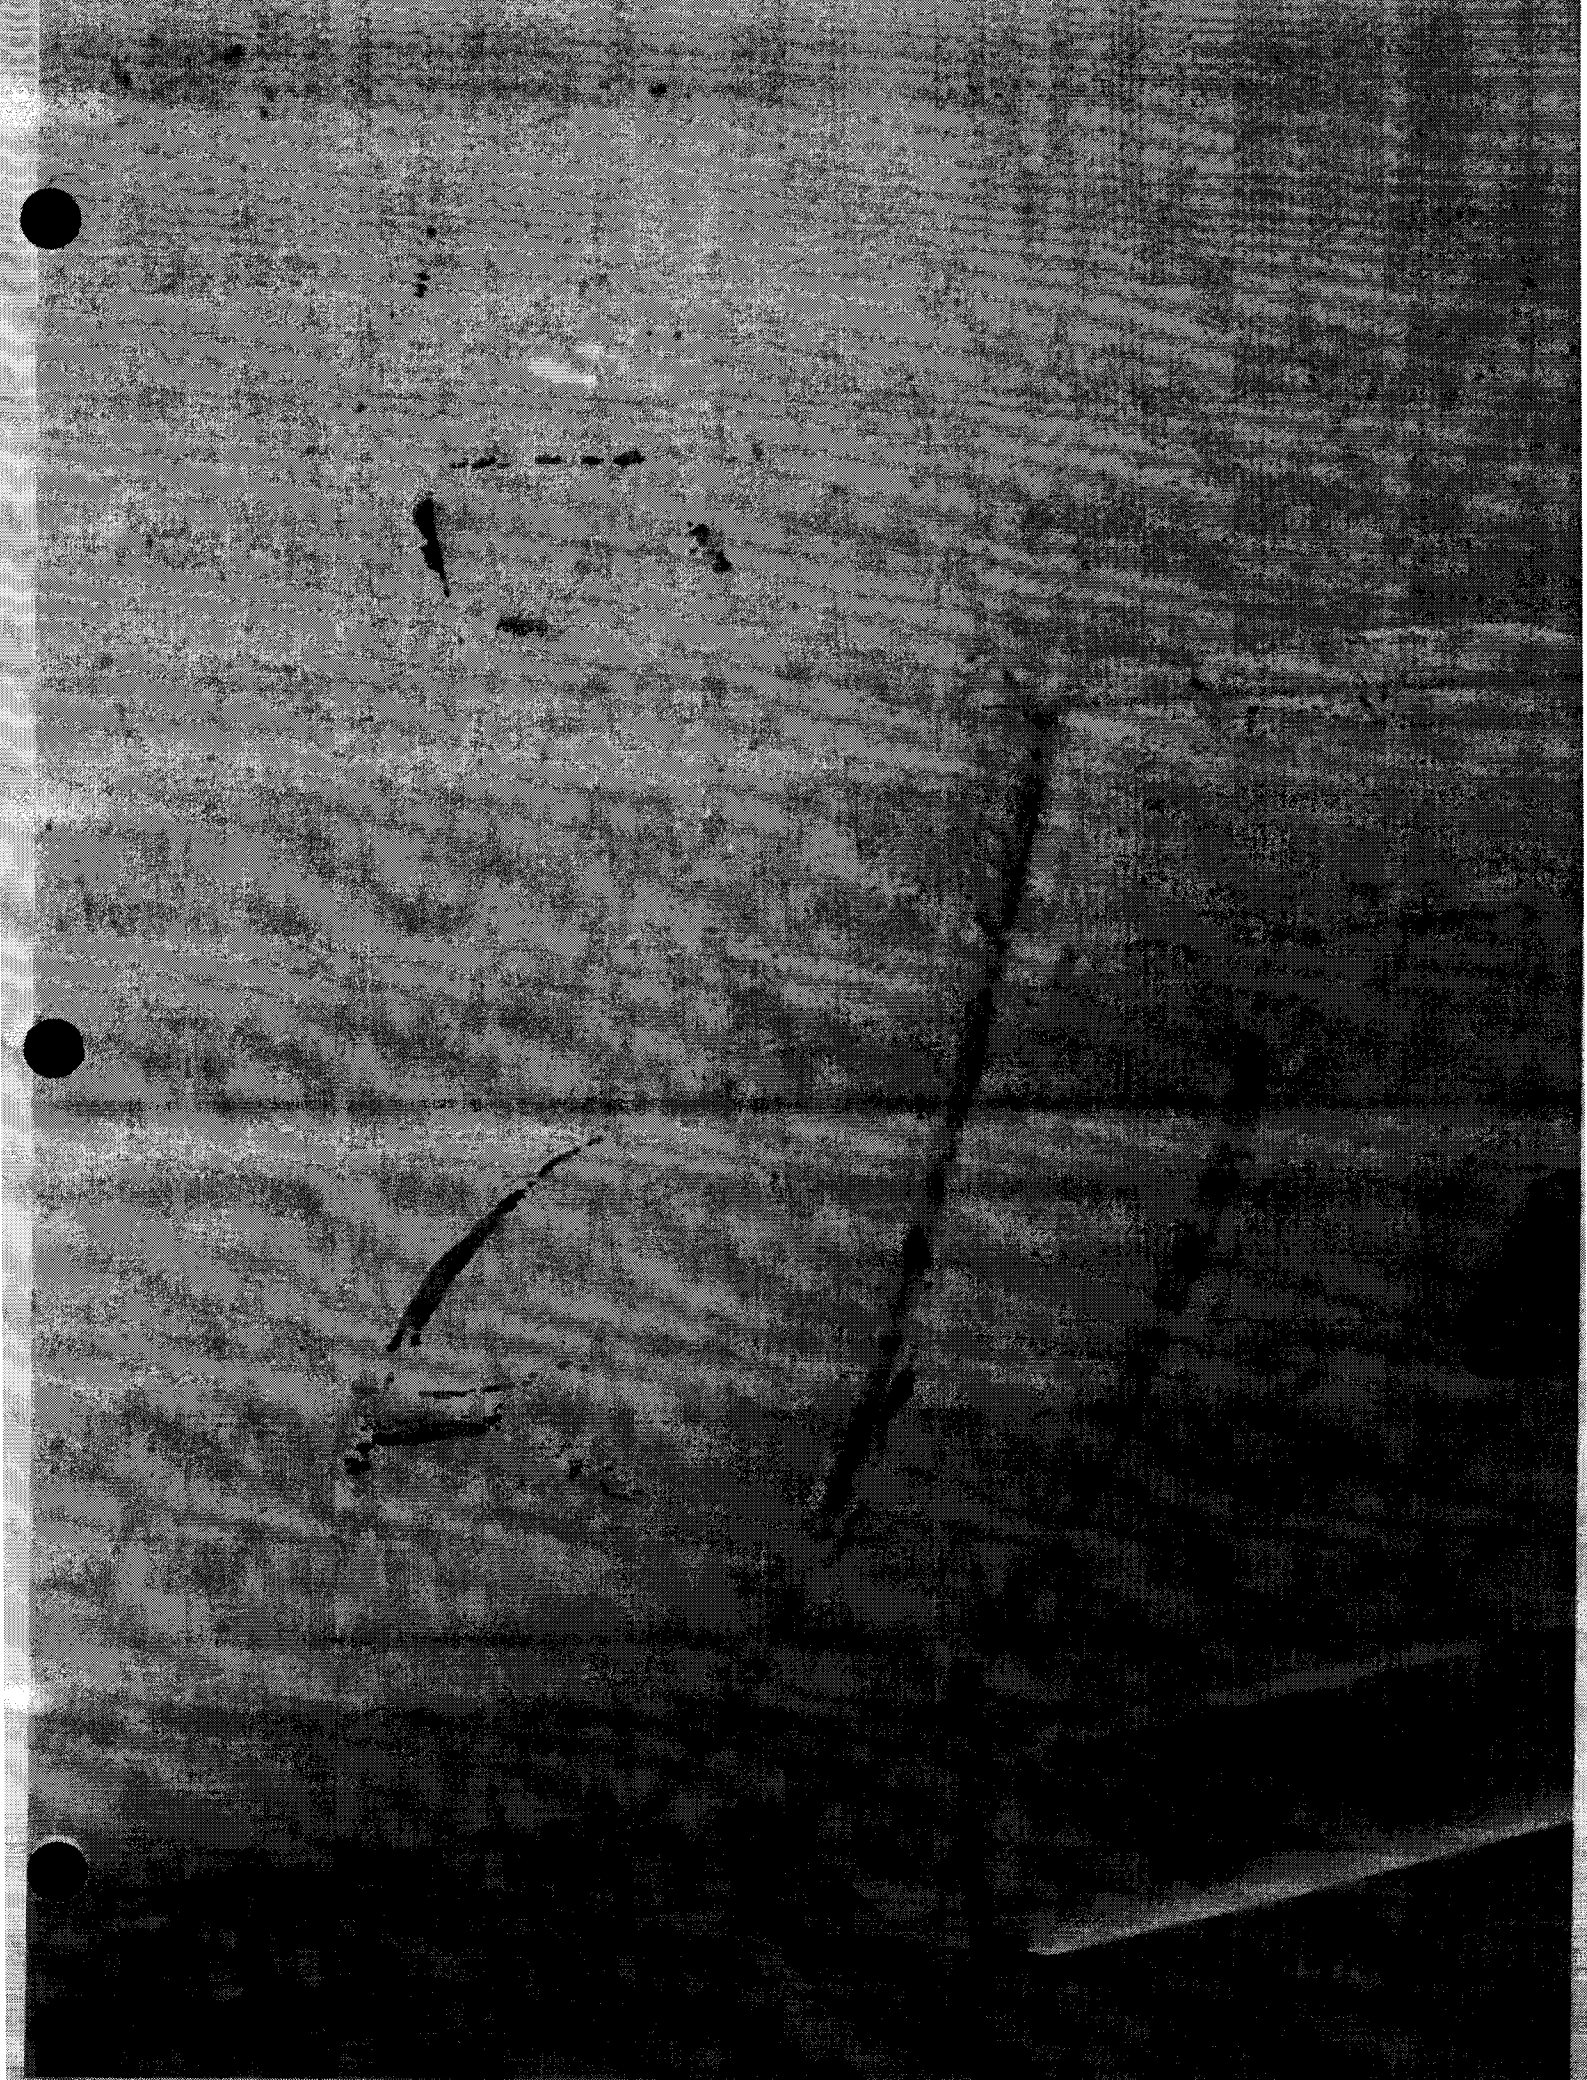
Paint failures

no
leaks

Complete coating repairs.

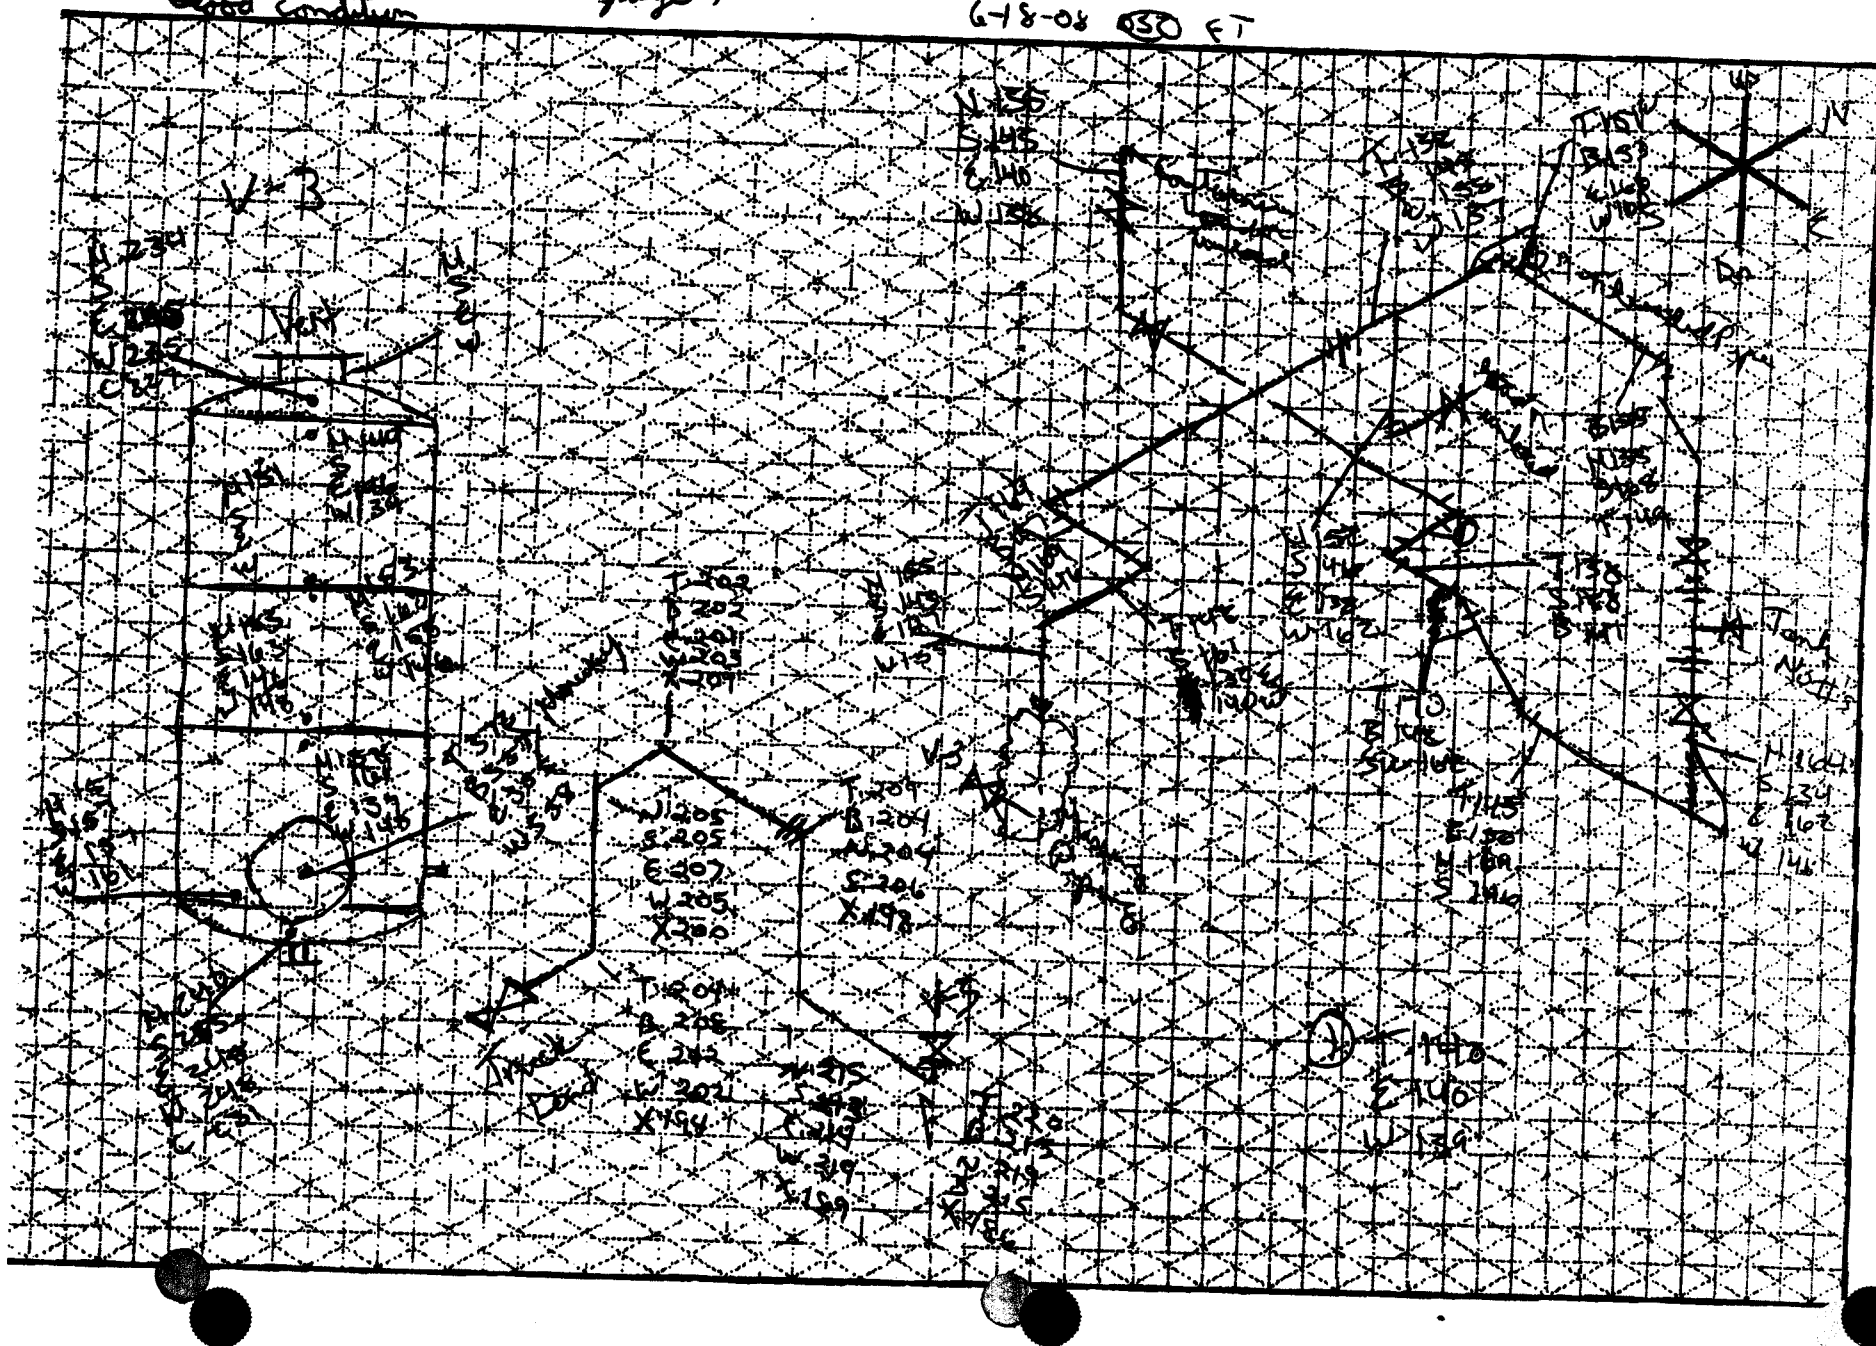
light corrosion on shell

paint failures on head
and piping.

Complete coating repairs.

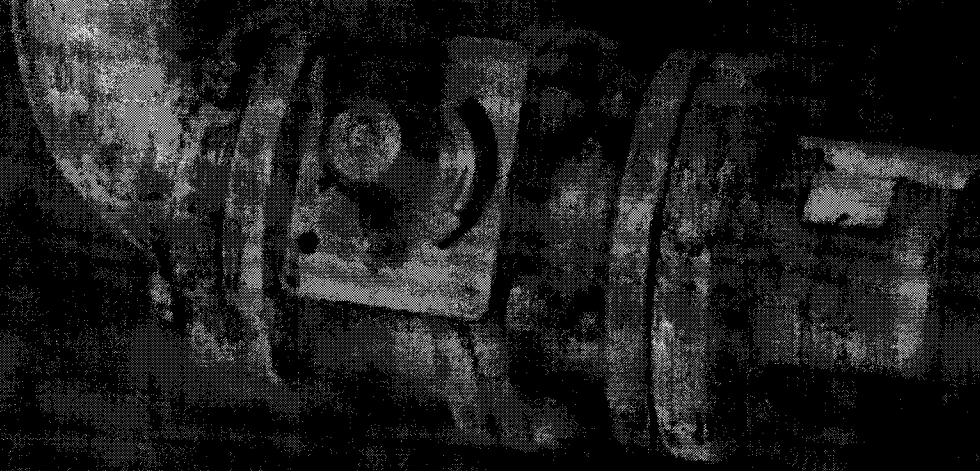
**light
corrosion on
internal
surfaces**

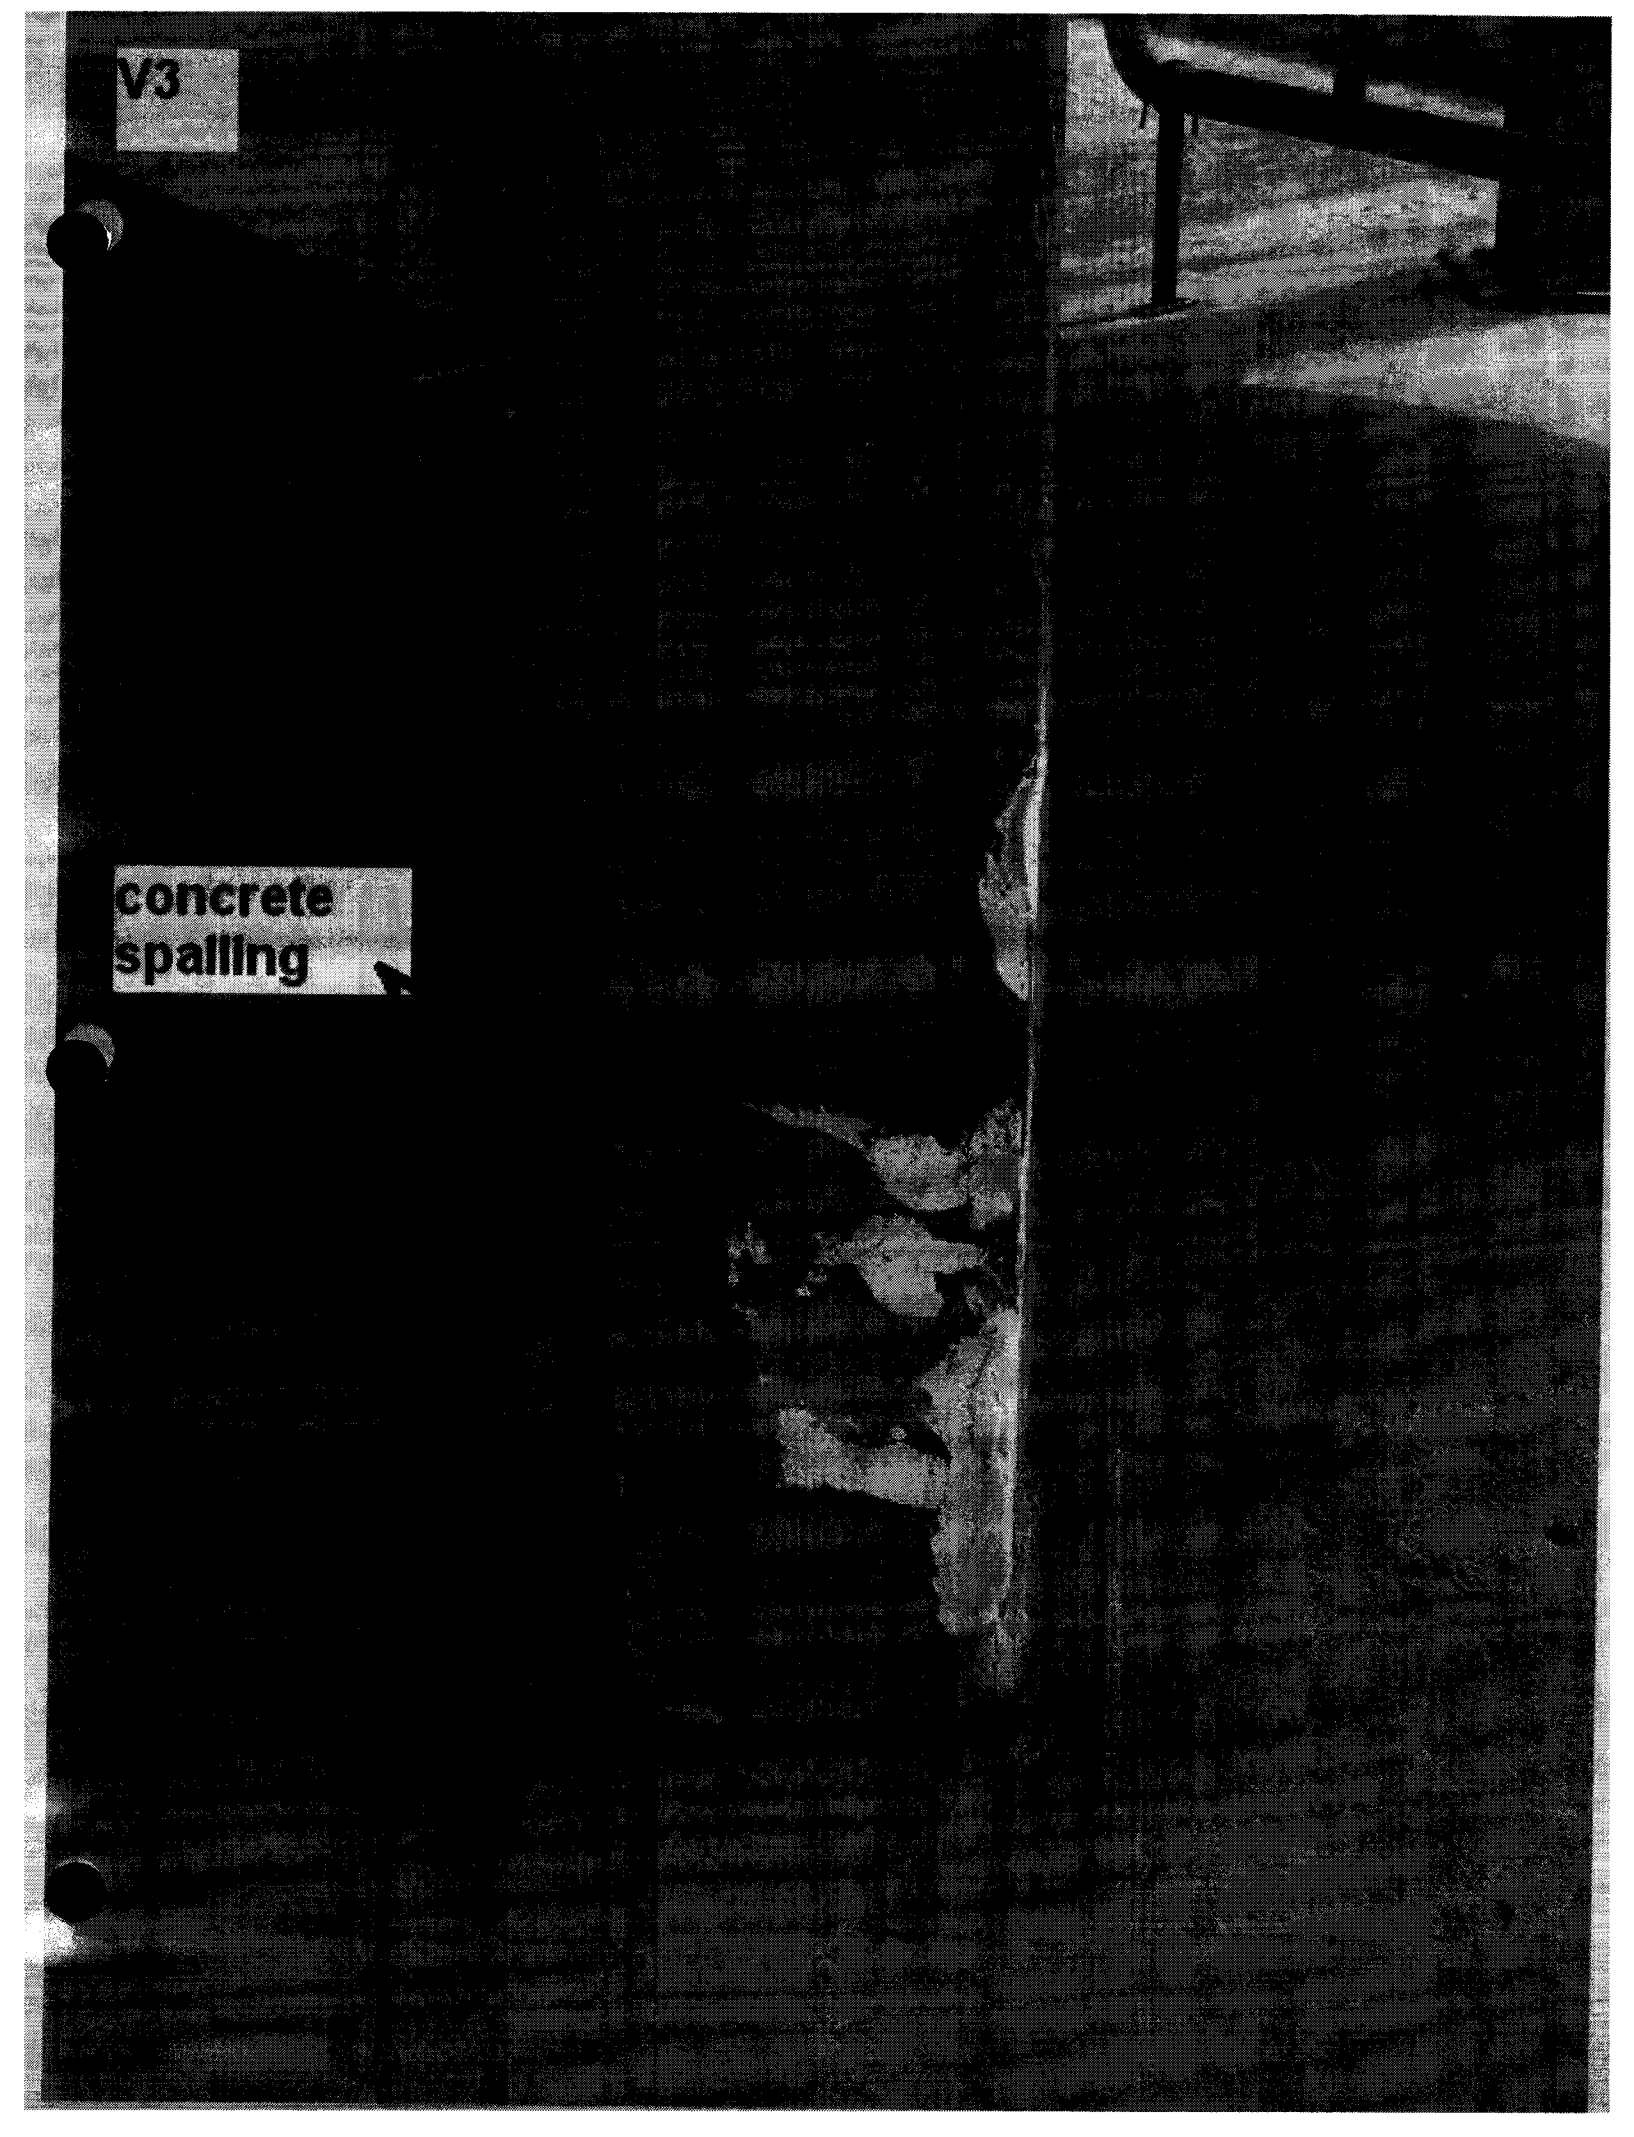
Paint failures on vessel

concrete
spalling

Areas of
paint
failure

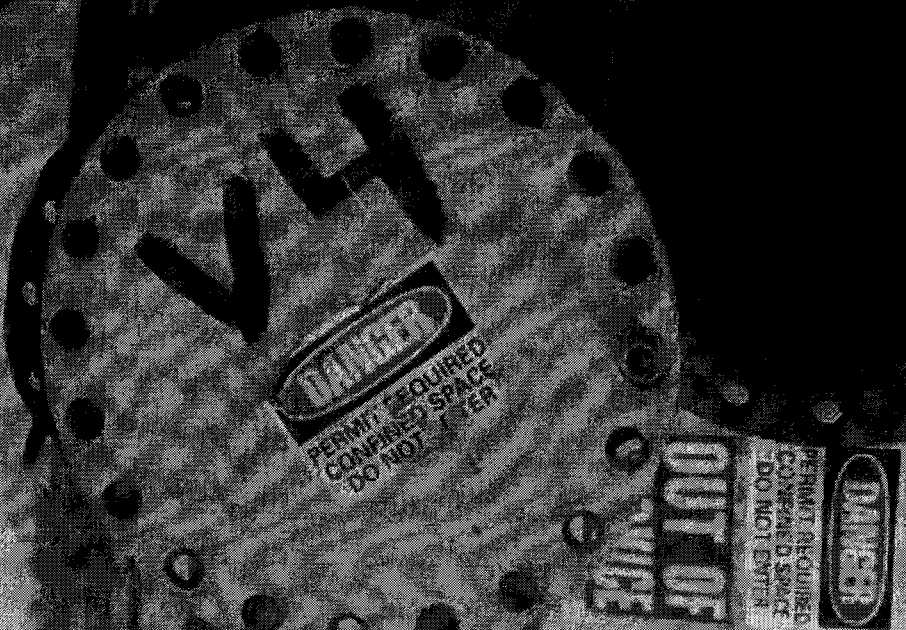
guage glass
clear

paint failure

Complete coating repairs.
